The Banklick Watershed Based Plan

Kenton and Boone Counties

A Holistic Approach to Watershed Improvement

Revised and Updated by Strand Associates, Inc.[®]
April 2010

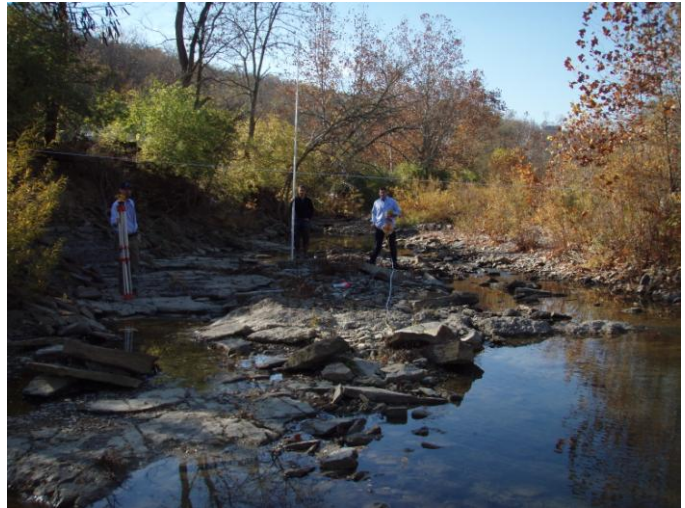
Figure 4.03-12 Hydromodification Survey in Banklick Creek Mile 8.1

The USEPA defines hydromodification as the “alteration of the hydrologic characteristics of coastal and noncoastal waters, which in turn could cause degradation of water resources” (EPA 2006). Simply stated, hydromodification is a change in a waterbody's physical structure as well as its natural function. These changes can cause many problems such as changes in flow, increased sedimentation, higher water temperature, lower dissolved oxygen, degradation of aquatic habitat structure, loss of fish and other aquatic populations, and decreased water quality. The term is most often used in reference to the hydrologic changes caused by the conversion of land from undeveloped to urban. If left unmitigated, the increases in impervious surfaces, such as roofs, parking lots, and roads, result in increased surface runoff and higher flow magnitudes and durations for equivalent rainfalls relative to the undeveloped setting. Some of the effects of hydromodification include an altered sediment delivery from the watershed, increased sediment transport within channels, and changes in channel forms. SD1 took a proactive approach to managing hydromodification and began collecting data from the Northern Kentucky streams in the summer of 2008. Stream survey data and pebble count data are being collected for five cross sections along Banklick Creek at RMs 5.5, 8.1, 17.6, 17.8, and 18.0. This information is being used to determine the critical flow rates within the stream channel that cause sediment transport and degrade the stream quality. SD1
